2008-2009 Mariner

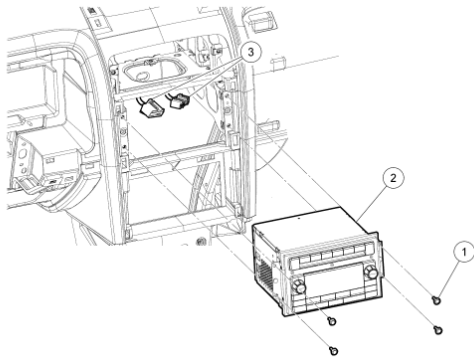
Figure A

Using a 7mm socket unscrew four screws holding radio and pull radio forward. (See figure A)

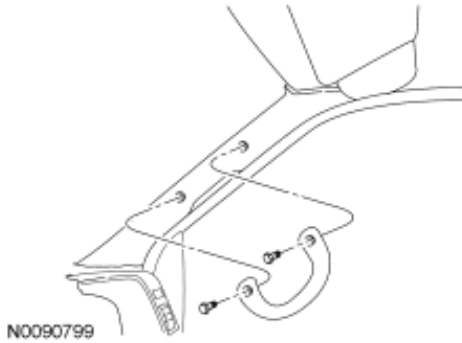
Figure B

Remove the A-pillar trim by first removing the assist handle covers and remove the two bolts holding the handle to the body. (See Figure B)

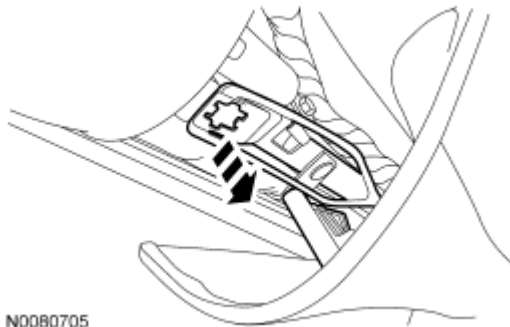
Figure C

Remove the A-pillar trim bezel by pulling on the upper part of the trim bezel toward the center of the vehicle. Once the bezel is loose remove the tether holding the bezel to the A-pillar insuring not to damage the tether. (If tether is damaged during removal and or installation a new tether must be used in order to assure proper operation of side curtain airbag system). (See figure C)
