## 2009 MKS

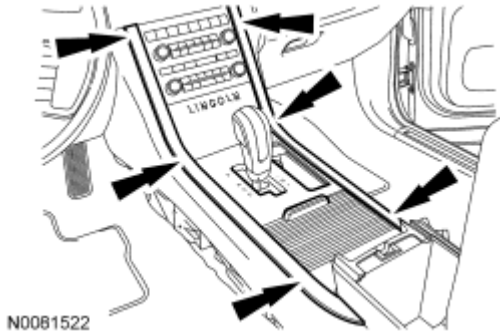
**Figure A**

Remove both sides of console trim. (See figure A)

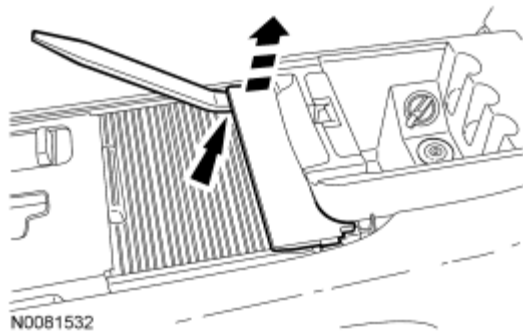
**Figure B**

Remove center console center bezel. (See figure B)
